INFRARED INSPECTION REPORT

**5207 Piedmont Run Rd**

Mt Holly, NC 28120

INSPECTION DATE 6/4/2026 REPORT ID 060426CS220940

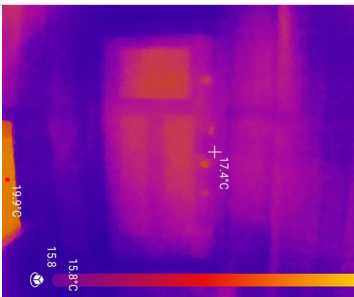
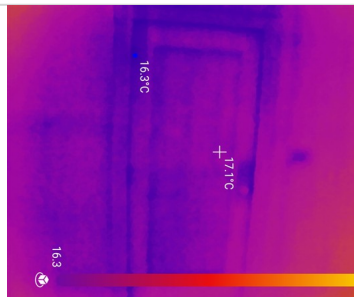
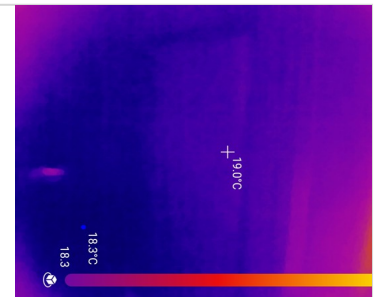
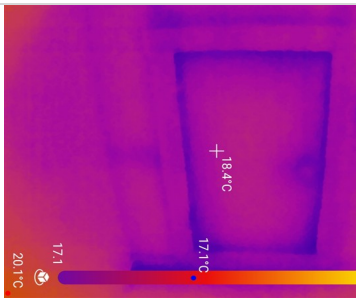
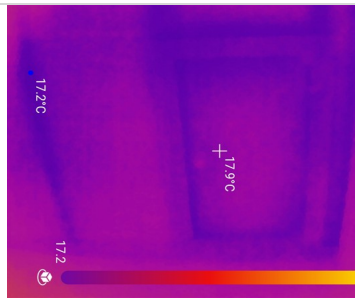
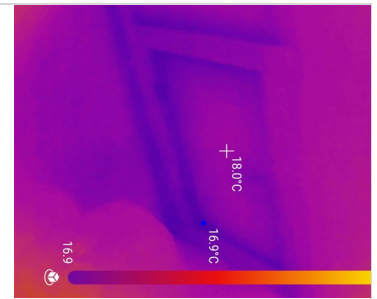
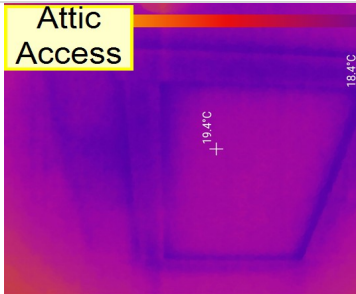
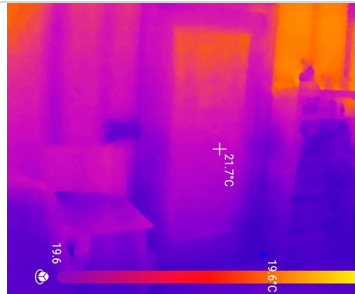
Normal or typical conditions viewed at the time of inspection.

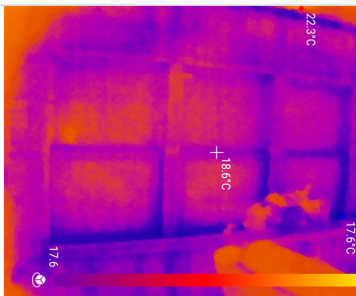
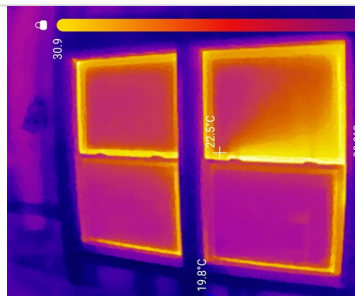
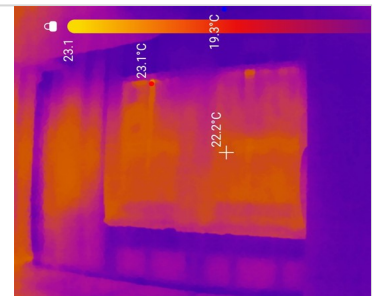
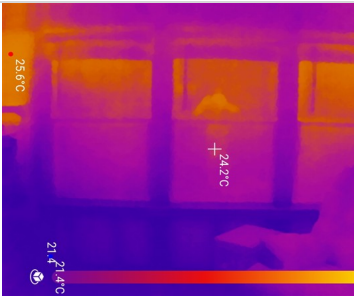
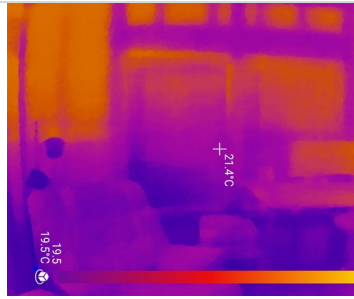
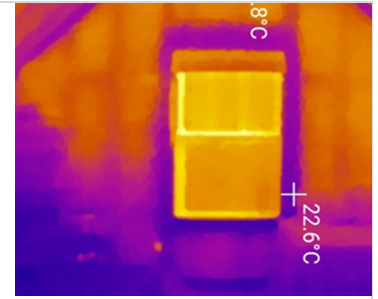
Normal or typical conditions viewed at the time of inspection.

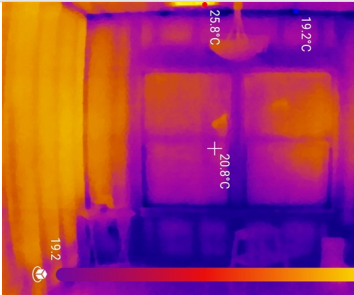
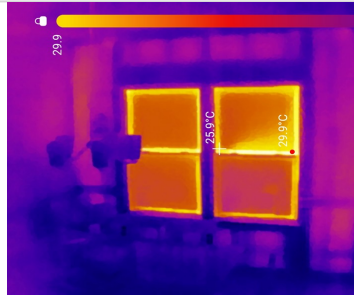
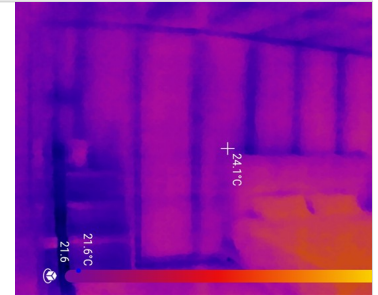
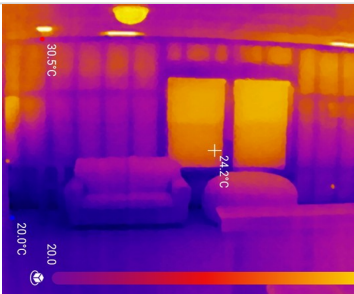
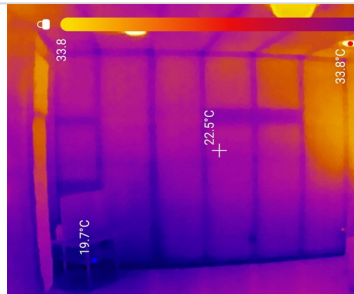
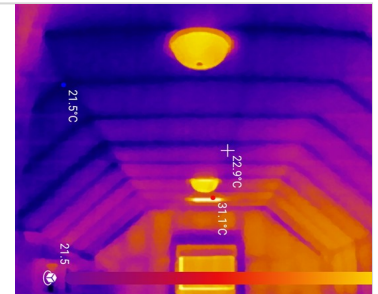
Normal or typical conditions viewed at the time of inspection.

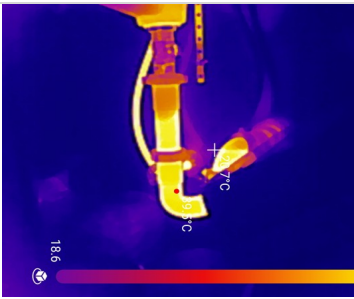
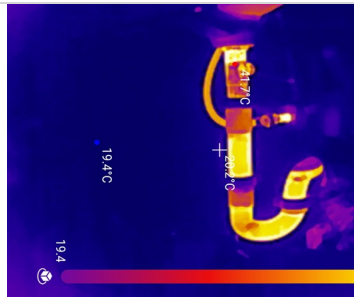
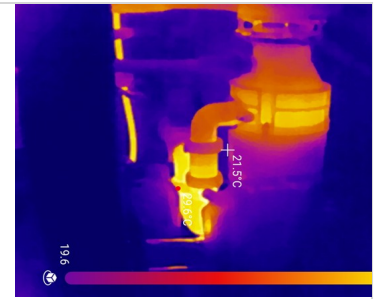
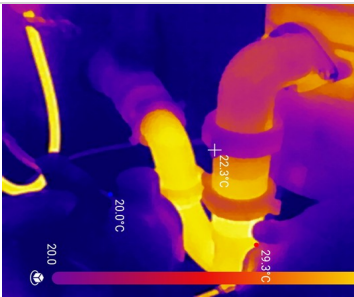
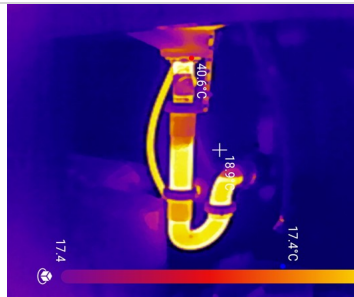
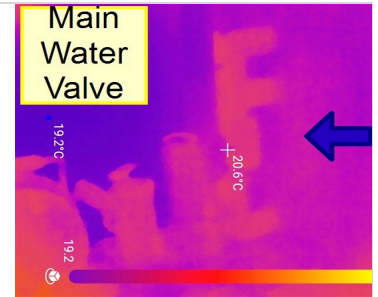
Performing the function for which intended at the time of inspection.

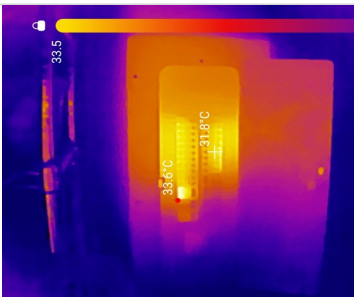
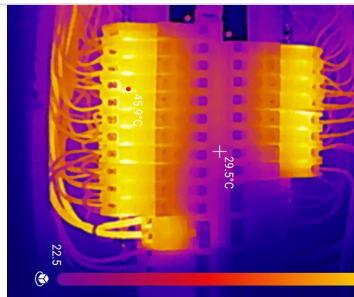
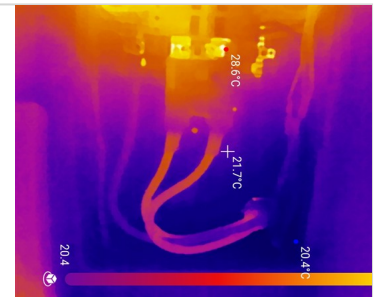
Performing the function for which intended at the time of inspection.

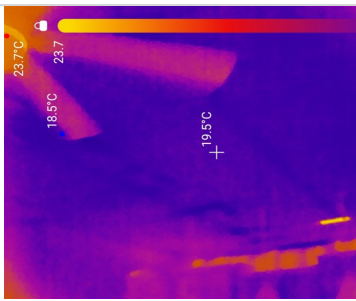
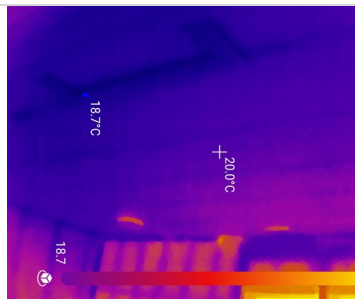
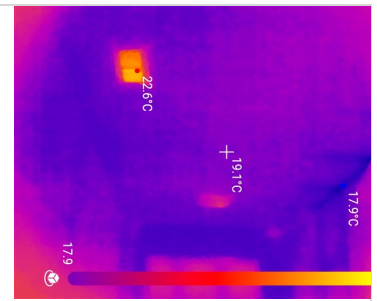
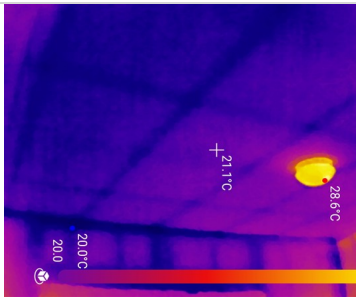
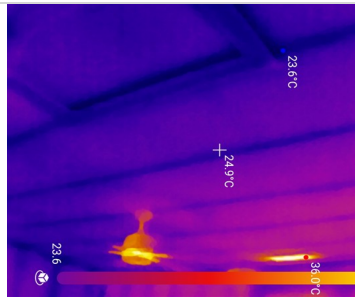
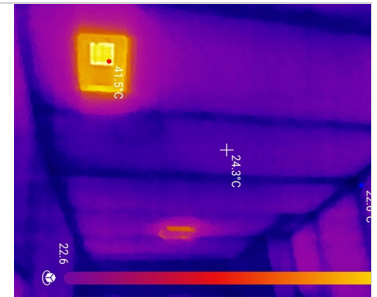
Normal or typical conditions viewed at the time of inspection.

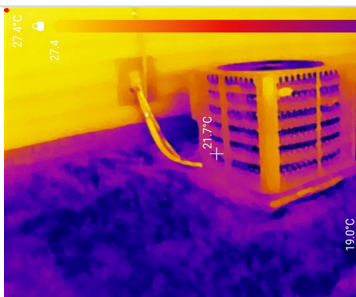
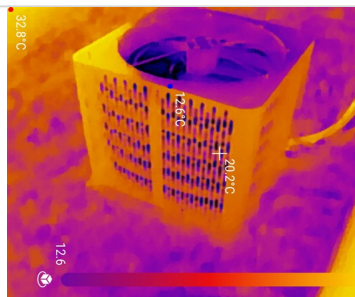
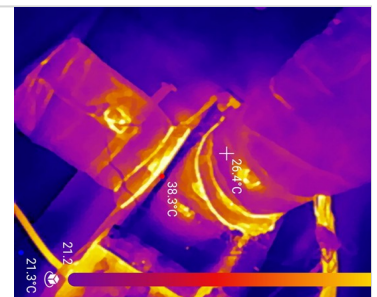
Performing the function for which intended at the time of inspection.
