**INSPECTION REPORT**

**7933 Parknoll Dr**

Huntersville, NC 28078

**INSPECTION DATE** 6/11/2026

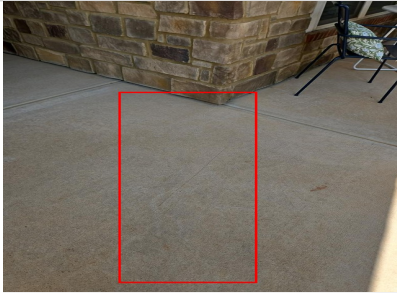
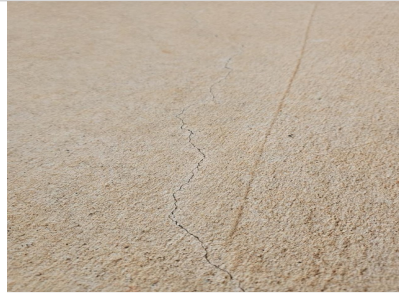
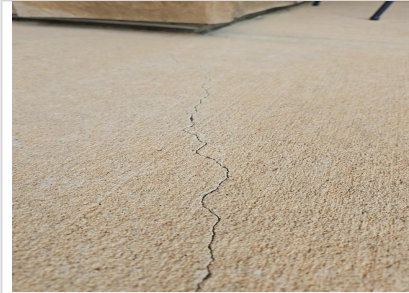
Cracking was present at the front porch concrete surface. Cracks in concrete porch surfaces can allow further separation and may create uneven walking surfaces. Correction is needed to help maintain the porch surface. Have a qualified general contractor evaluate and correct as needed.

1. Cracking was present at the front porch concrete surface. Cracks in concrete porch surfaces can allow further separation and may create uneven walking surfaces. Correction is needed to help maintain the porch surface.  
Have a qualified general contractor evaluate and correct as needed.

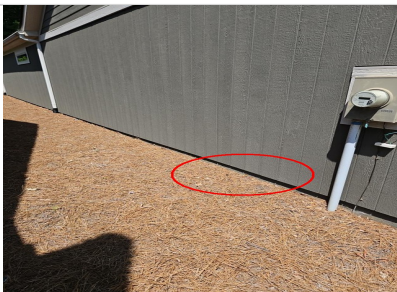
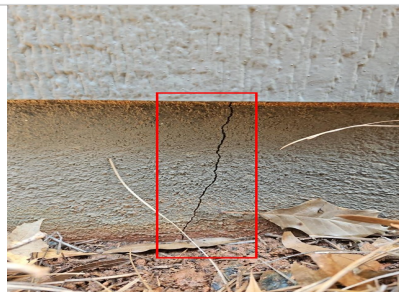
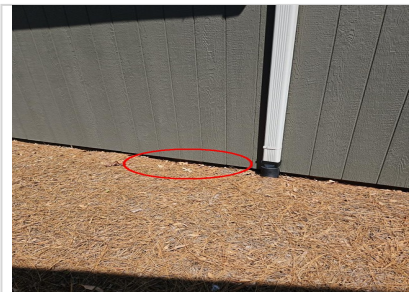
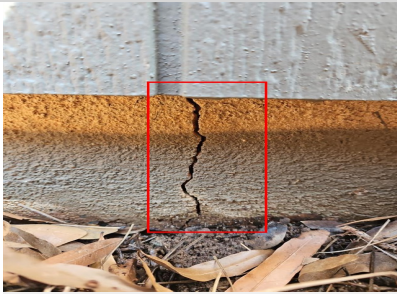
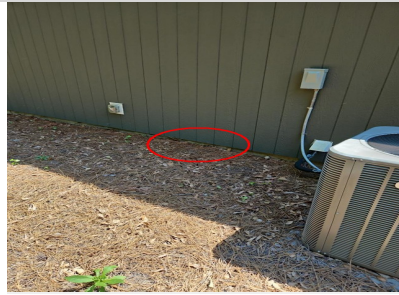
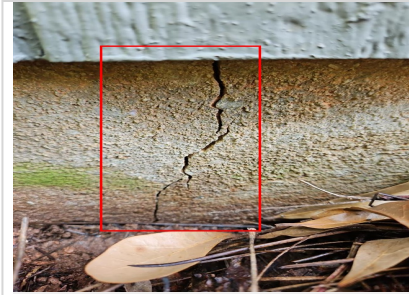
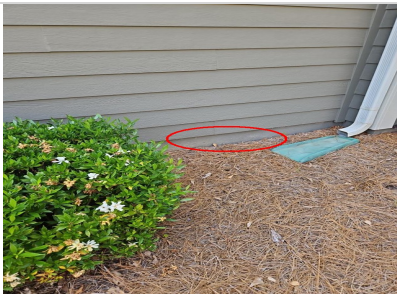
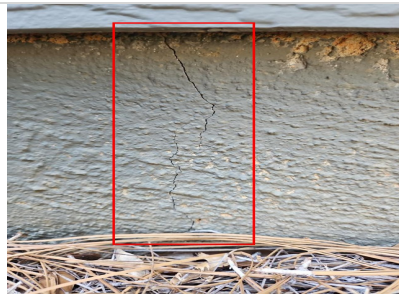
Cracking was present at the foundation at the left side, rear and right side areas of the home. Cracks in foundation surfaces can allow moisture entry. Correction is needed to help maintain the foundation surface. Have a qualified general contractor and or structural engineer evaluate and correct as needed.

2. Cracking was present at the foundation at the left side, rear and right side areas of the home. Cracks in foundation surfaces can allow moisture entry. Correction is needed to help maintain the foundation surface.  
Have a qualified general contractor and or structural engineer evaluate and correct as needed.

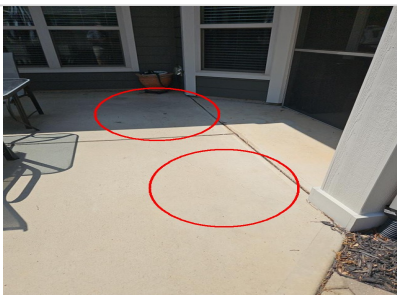
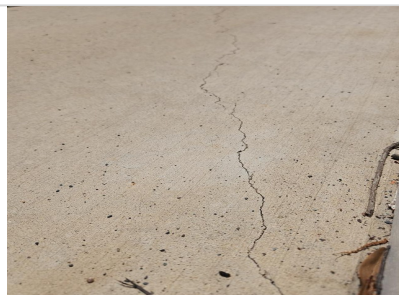
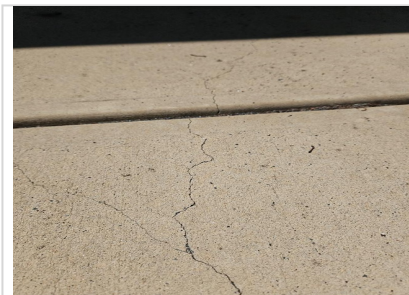
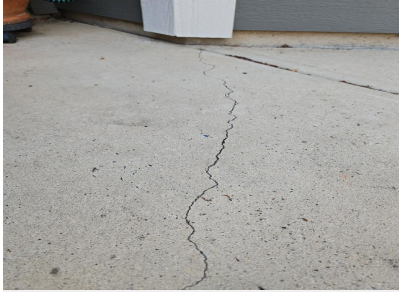
Cracking was present at the rear patio concrete surface. Cracks in concrete patio surfaces can allow further separation and may create uneven walking surfaces. Correction is needed to help maintain the patio surface. Have a qualified general contractor evaluate and correct as needed.

- Cracking was present at the rear patio concrete surface. Cracks in concrete patio surfaces can allow further separation and may create uneven walking surfaces. Correction is needed to help maintain the patio surface.  
Have a qualified general contractor evaluate and correct as needed.

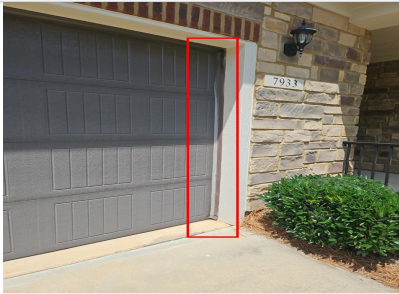
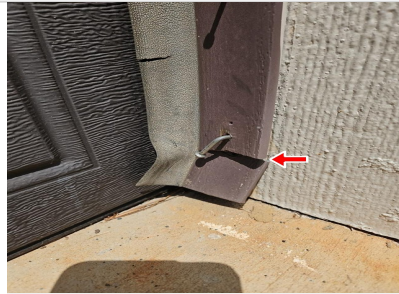
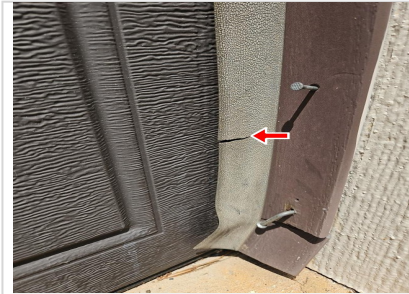
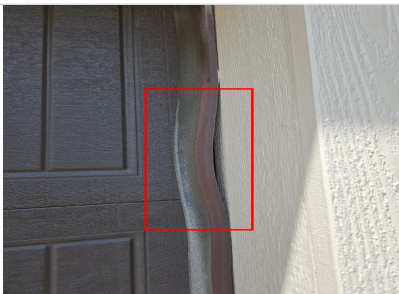
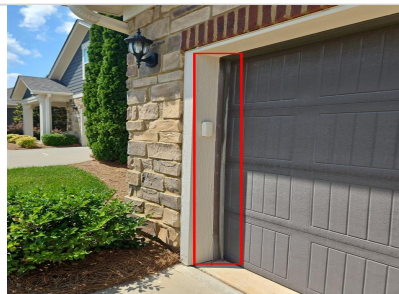
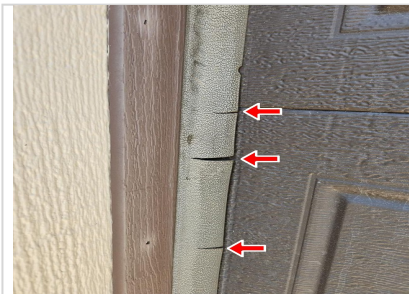
The weatherstripping and trim around the garage door were damaged and warped. Damaged or warped garage door trim and weatherstripping can allow moisture, air and pests to enter around the garage door opening. Correction is needed to help maintain the garage door opening. Have a qualified general contractor evaluate and correct as needed.

4. The weatherstripping and trim around the garage door were damaged and warped. Damaged or warped garage door trim and weatherstripping can allow moisture, air and pests to enter around the garage door opening. Correction is needed to help maintain the garage door opening.

Have a qualified general contractor evaluate and correct as needed.

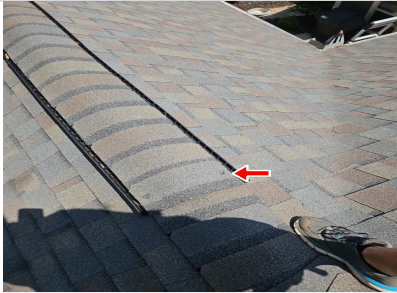
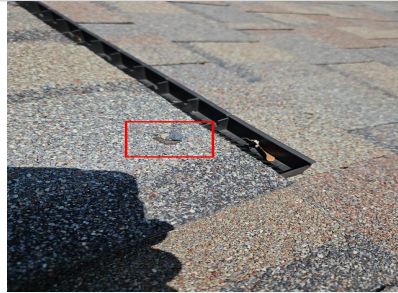
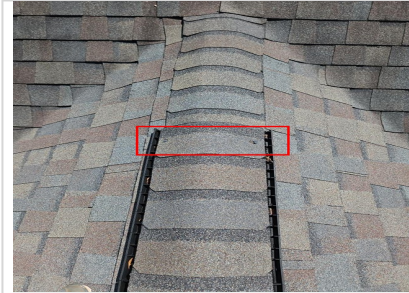
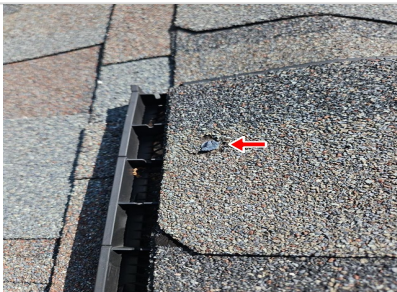
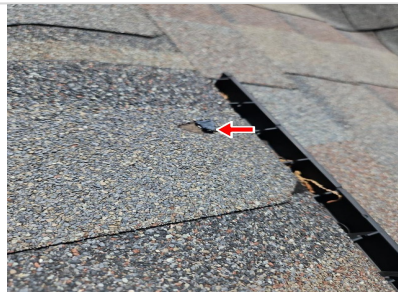
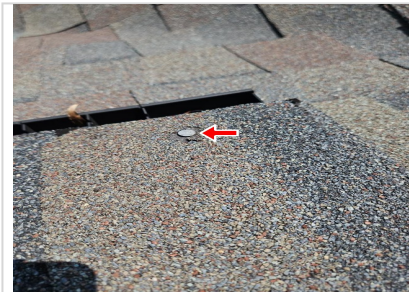
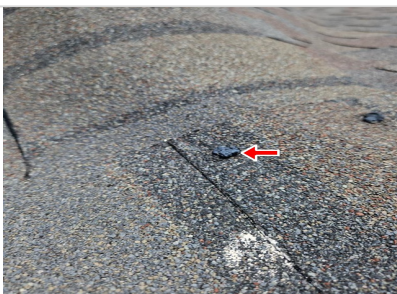
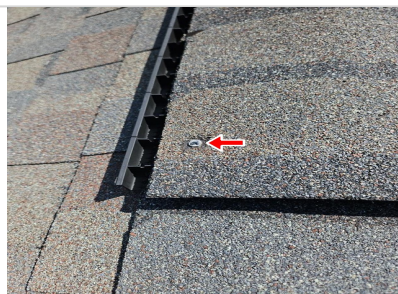
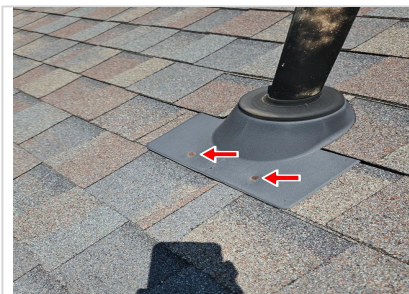
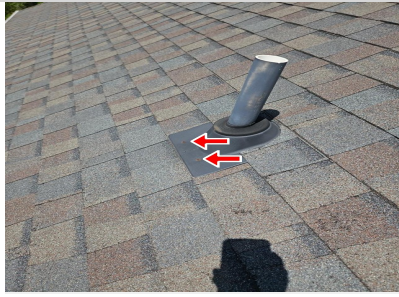
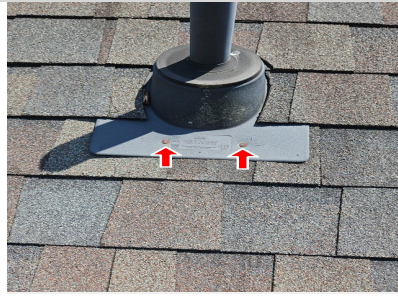
Exposed nails were present at multiple roof areas. Exposed nails can allow moisture entry through the roof covering. Correction is needed to help maintain the roof covering.  
Have a qualified roofing contractor evaluate and correct as needed.

5. Exposed nails were present at multiple roof areas. Exposed nails can allow moisture entry through the roof covering. Correction is needed to help maintain the roof covering. Have a qualified roofing contractor evaluate and correct as needed.

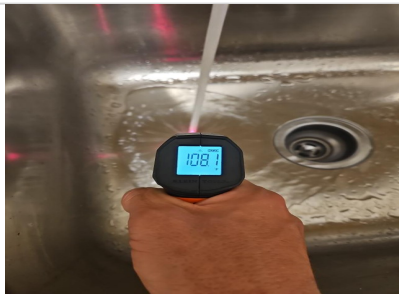
Item 6 - Item 1 (Picture)

6. The hot water temperature measured approximately 108 degrees at the tested fixture. Water temperatures below 120 degrees may not provide adequate hot water for normal use and can allow bacterial growth inside a tank style water heater. Correction is needed for proper hot water temperature.

Have a qualified plumbing contractor evaluate and correct as needed.

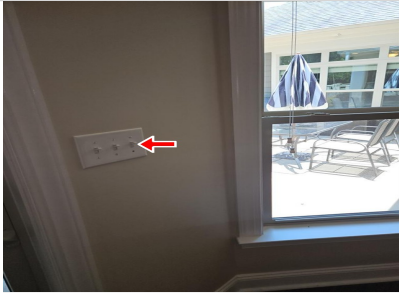
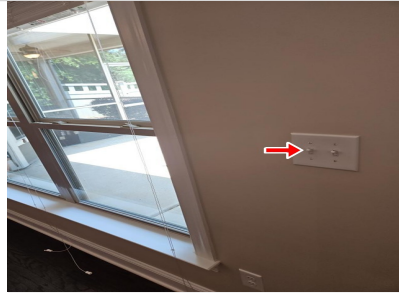
7. (1) Unidentified 3 way switches were present at the primary bedroom rear exterior door and at the rear exterior door near the kitchen. Switches with no identified function may indicate disconnected, abandoned or non functioning electrical components. Further evaluation is needed to determine their function.

Have a licensed electrician evaluate and correct as needed.

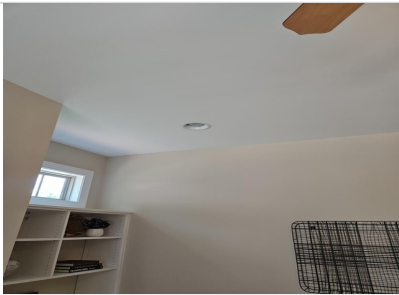
**Item 8 - Item 1 (Picture)**

8. (2) The living room light did not function when tested. Non functioning lighting can be due to a bulb, fixture, switch or wiring issue. Correction is needed for proper light operation.

Have a licensed electrician evaluate and correct as needed.

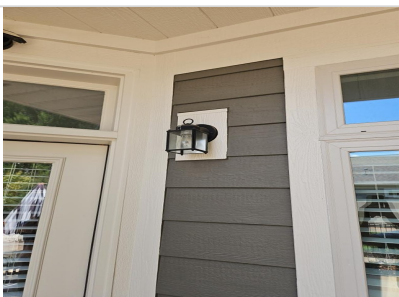
**Item 9 - Item 1 (Picture)**

9. (3) The rear exterior light did not function when tested. Non functioning exterior lighting can limit visibility at exterior walking areas. Correction is needed for proper light operation.

Have a licensed electrician evaluate and correct as needed.

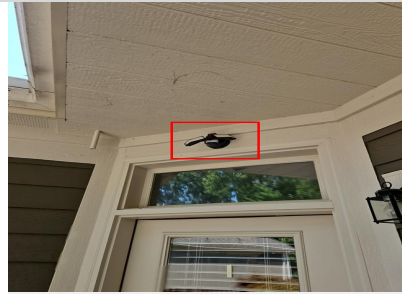
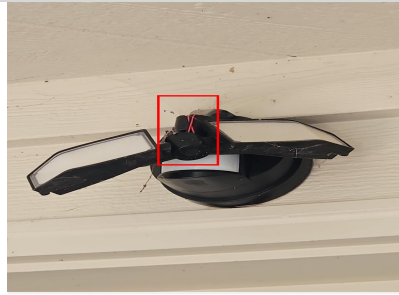
(4) The rear exterior light above the door was broken and did not function when tested. Broken exterior lighting can expose electrical components and prevent proper lighting at the door area. Correction is needed for proper light operation.

10. (4) The rear exterior light above the door was broken and did not function when tested. Broken exterior lighting can expose electrical components and prevent proper lighting at the door area. Correction is needed for proper light operation.

Have a licensed electrician evaluate and correct as needed.

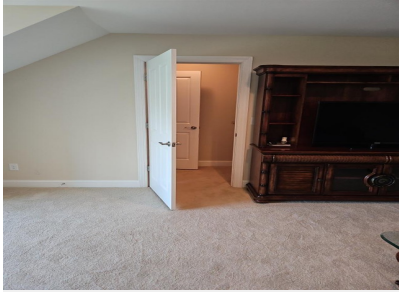
Item 12 - Item 1 (Picture)

12. The door at the top of the stairs leading to the loft did not latch. Doors that do not latch may not remain secured during normal use. Correction is needed for proper door operation. Have a qualified general contractor evaluate and correct as needed.

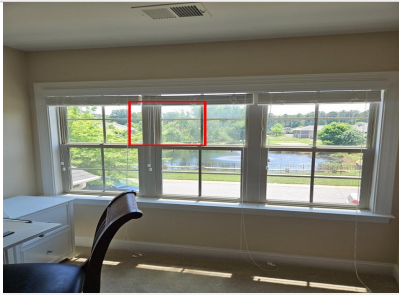
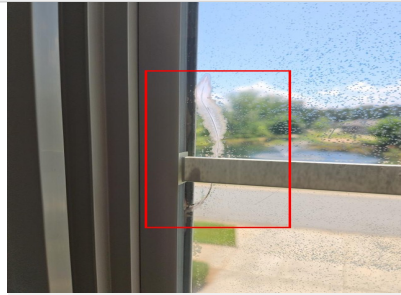
13. Cracked glass was present at the second floor front window. Cracked glass can worsen with use and may reduce safe window function. Correction is needed to restore the window.
- Have a qualified general contractor evaluate and correct as needed.

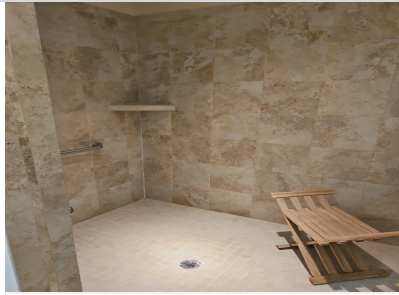
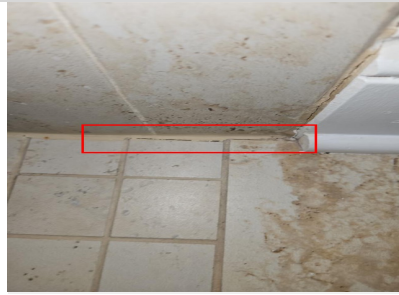
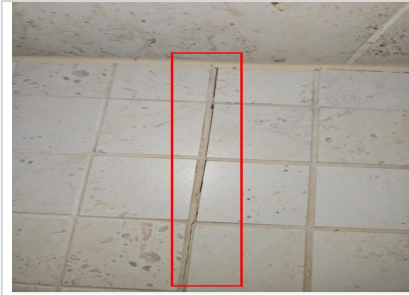
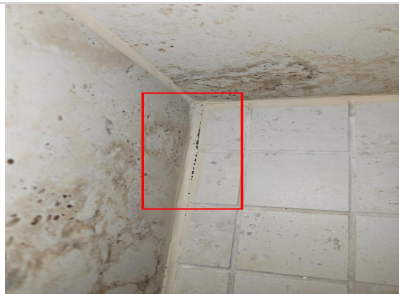
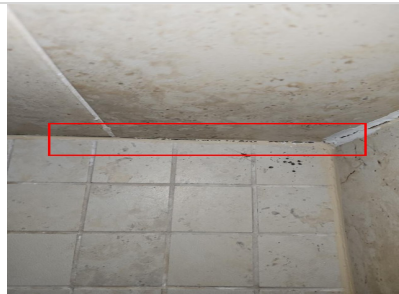
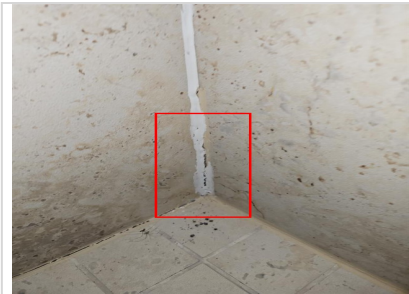
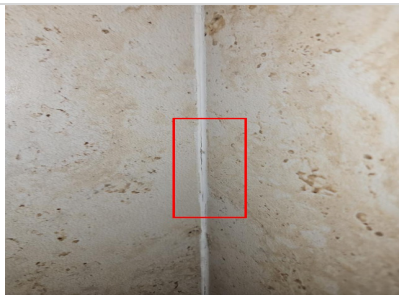
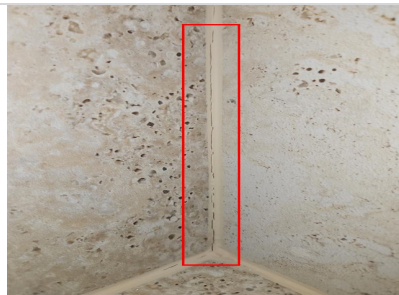
14. (1) Gaps were present at mortar or sealant joints at the primary bathroom shower walls and floor. Open joints at shower surfaces can allow moisture to enter concealed areas. Correction is needed to maintain the shower surface.
- Have a qualified general contractor evaluate and correct as needed.

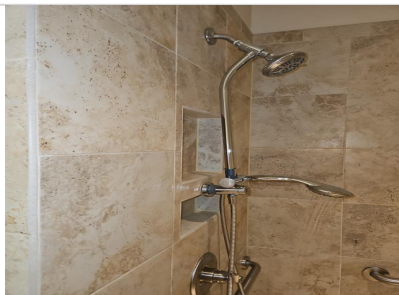
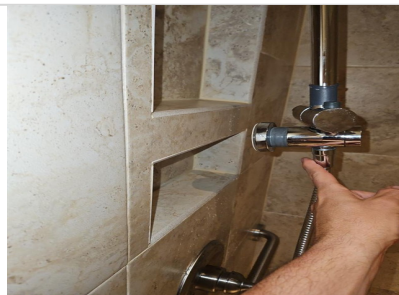
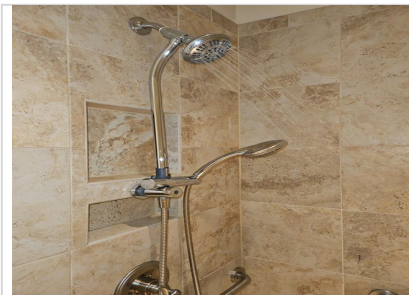
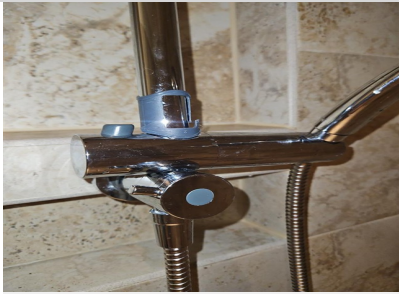
- 15.** (2) The primary bathroom shower faucet was loose and did not adjust easily. Loose or difficult to adjust shower controls may indicate the fixture is not properly secured or functioning as intended. Correction is needed for proper shower control operation.

Have a qualified plumbing contractor evaluate and correct as needed.

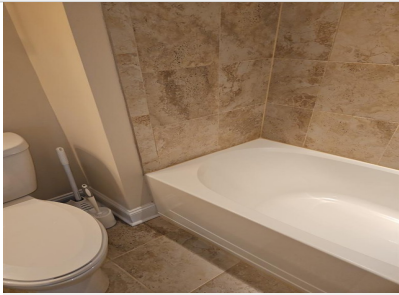
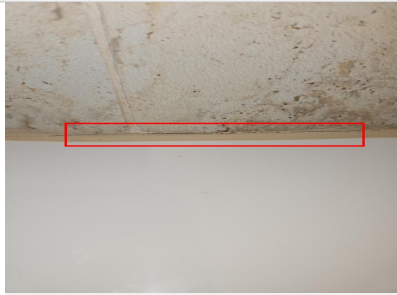
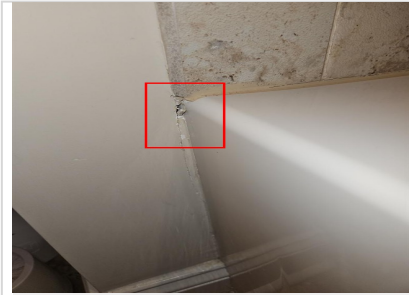
16. Gaps were present in the sealant or grout at the upstairs bathroom tub surround. Open joints at tub surround surfaces can allow moisture to enter concealed areas. Correction is needed to maintain the tub surround. Have a qualified general contractor evaluate and correct as needed.

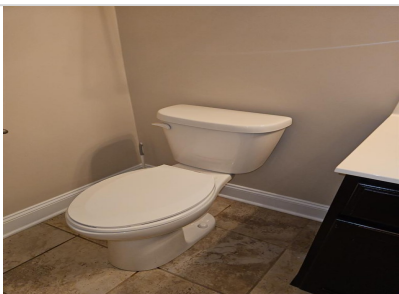
Item 17 - Item 1 (Picture)

17. The downstairs bathroom toilet tank was loose. A loose toilet tank can allow movement at the tank connection and may lead to leakage. Correction is needed for proper toilet function. Have a qualified plumbing contractor evaluate and correct as needed.

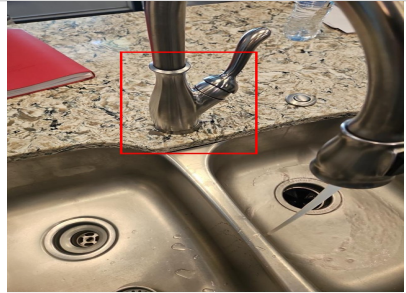
Item 18 - Item 1 (Picture)

18. The kitchen sink faucet was loose where it attaches to the countertop. A loose faucet can allow movement during use and may allow water to enter the countertop opening. Correction is needed for proper faucet function. Have a qualified plumbing contractor evaluate and correct as needed.
